# **Archaeological and Monumental Heritage of Bayana**

**Superintending Archaeologist**

**Archaeological Survey of India**

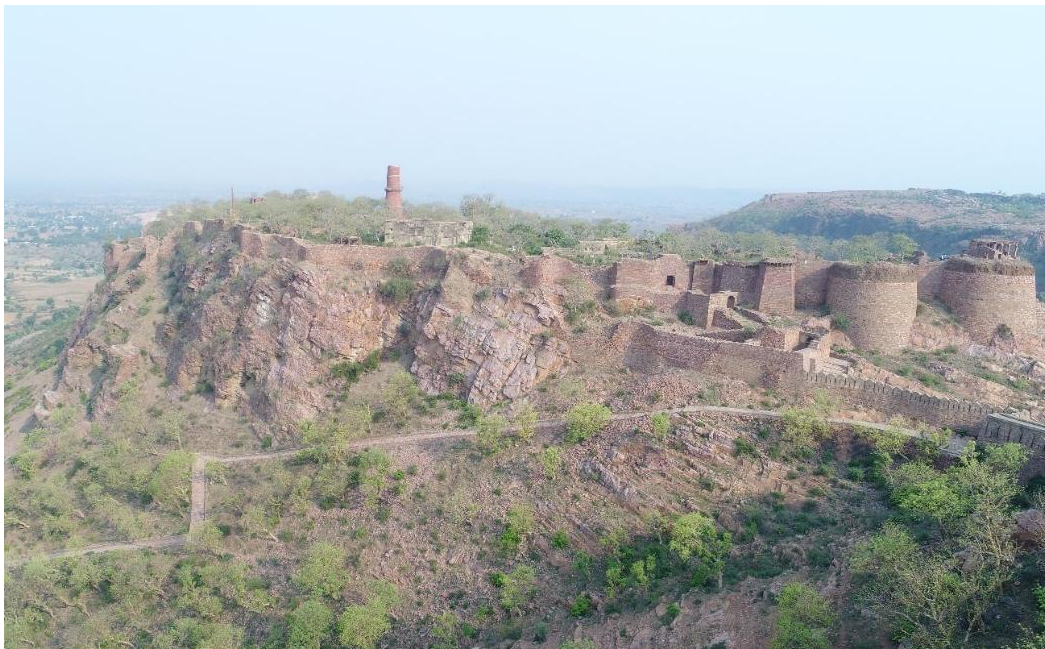
**A general view of Bayana Fort**

The foundation of the fort is laid on Mani hill in such an inaccessible tract. Its massive outer wall encircles an extensive area and is robustly constructed, featuring pierced battlements. A continuous line of parapets safeguards the ascent, which is narrow, winding, and strategically circuitous. Traversing a chaotic expanse of rocky ground, this zigzag approach ascends towards the main gate, where a cluster of towers of varying sizes provides formidable defence. Opposite the main gate stands a semicircular tower, further strengthening the fortification.

Within the fort complex are the remains of several palaces, *baoris* (stepwells), *havelis*, temples, pillars, and *minars*. The most significant feature of the fort is an inscription dated V.S. 428 (372 CE), which records the erection of a sacrificial post on the completion of a 'Pundarika' sacrifice by Vishnuvardhana, who is believed to have been a feudatory of the Gupta ruler Samudragupta.

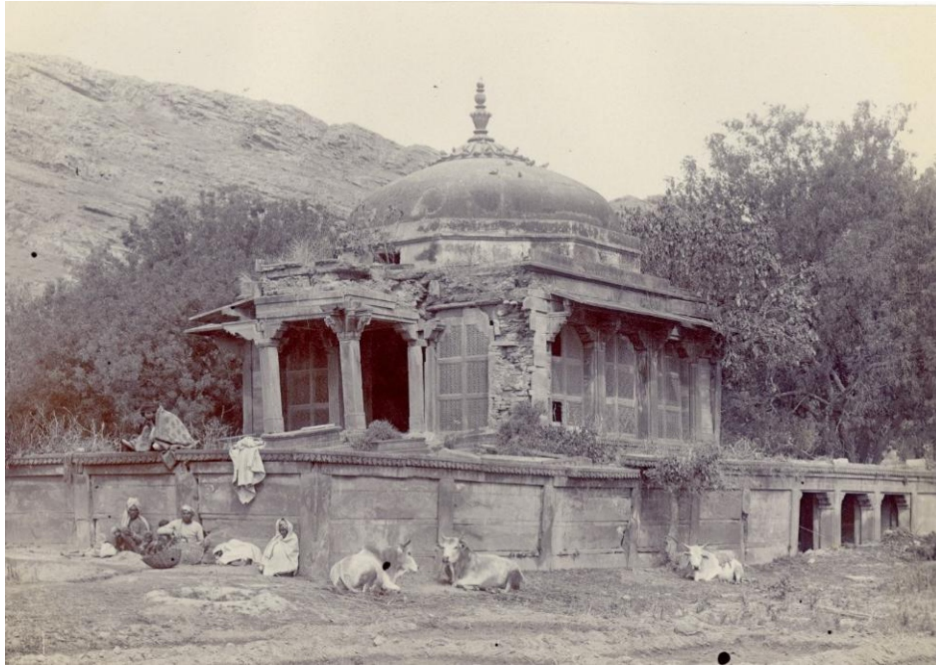
**An archival photo of Jhajri, 1904-05**

It is a medieval period building consisting of a square hall with pillared porch having entrance from south. In the exterior, each side has identical stone *jalis* within the arched gateways. The dome-shaped roof rests on an octagonal drum. The ceiling has traces of paintings. The structure stands on an underground chamber. This building was in all probability constructed during the reign of Emperor Akbar. A cenotaph is present in the underground chamber which should belong the person in whose memory this beautiful tomb structure was constructed.

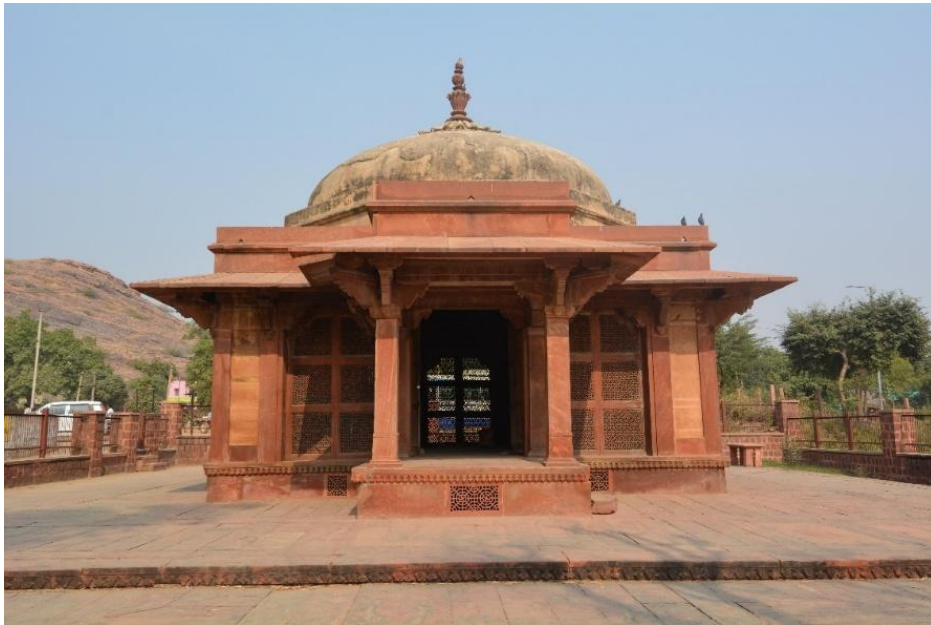
**Jhajri, present day view**

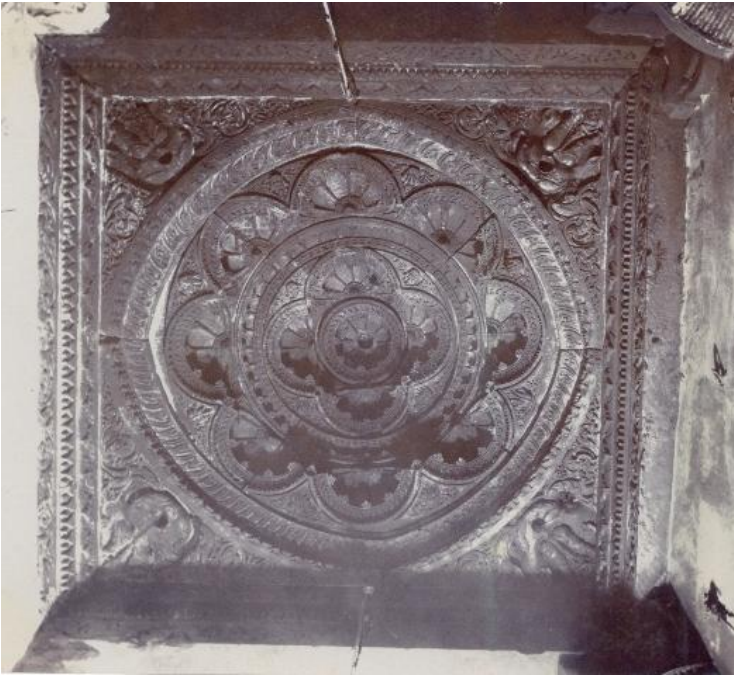
**Archival photo of Ceiling of Shrine of Usha Mandir of *Karotaka* type, 1923-35**

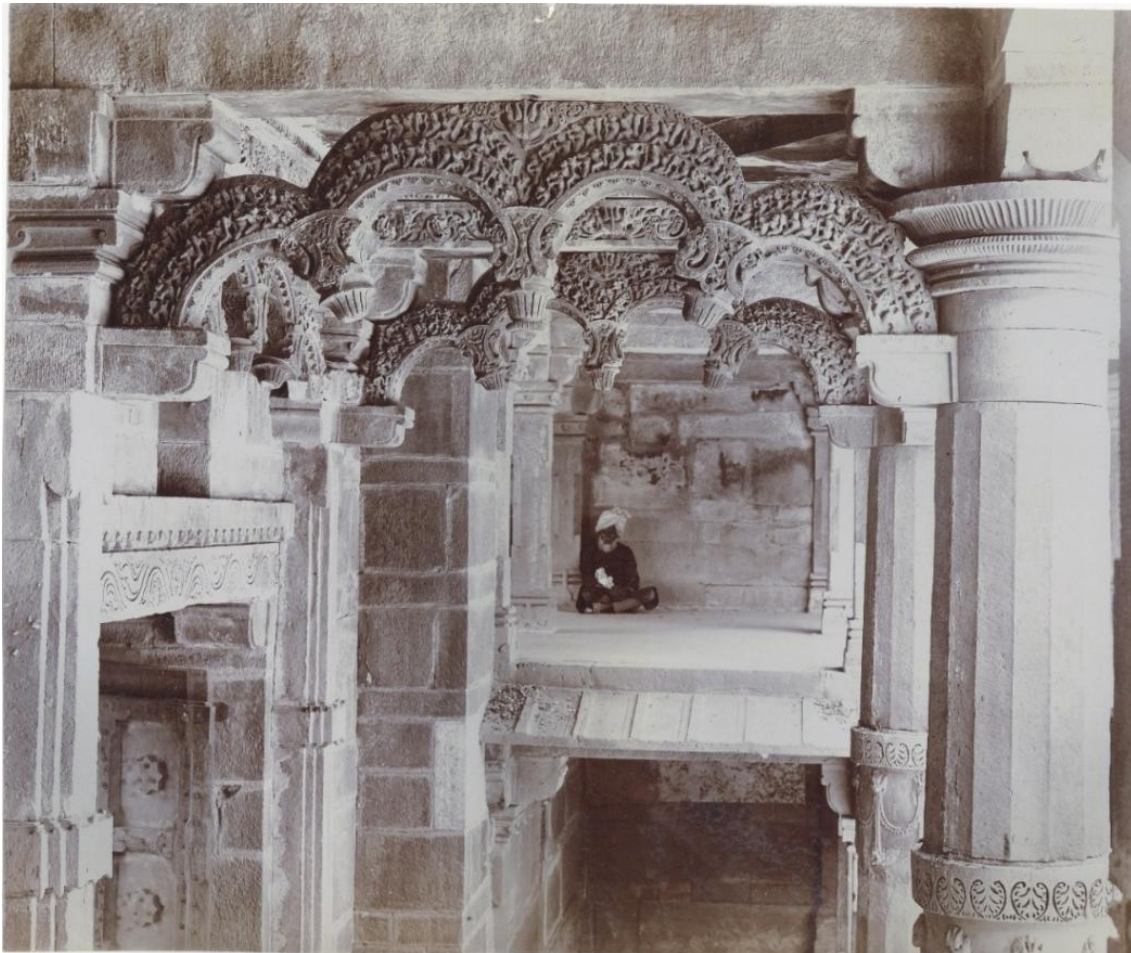
**An archival photo of Hindu *toranas* used inside Ukha Masjid**

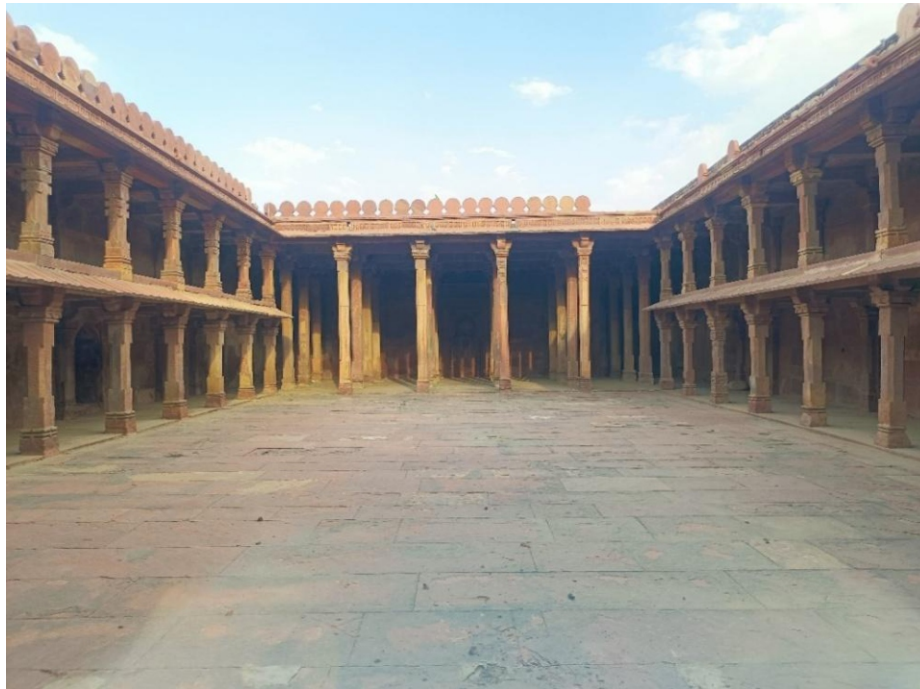
**Cloisters of Ukha Masjid**

The Ukha Masjid is a fourteenth century (built 1320 CE) historical monument in Bayana, Bharatpur, Rajasthan, situated just adjacent to the Usha Mandir. Built by Malik Kafur during the Khilji dynasty, it represents a blend of cultures, having been constructed on the site of Usha Mandir, possibly as an extension of Usha Mandir Mosque which was constructed on the ruins of the temple, just like the Quwattul' Islam Mosque in Mehrauli, Delhi and Chaurasi Khambha Mosque in Kaman.

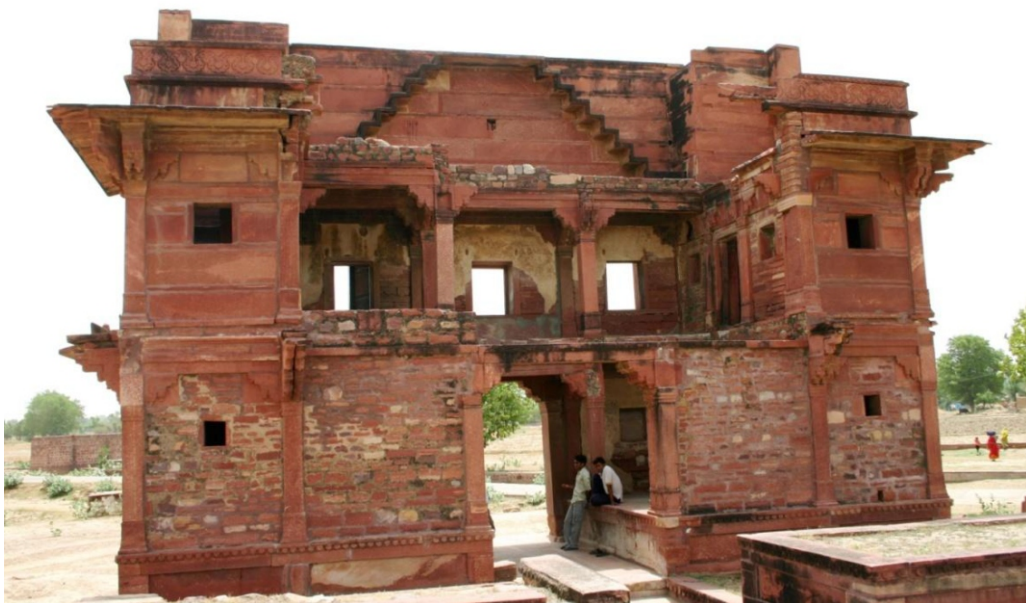
**Islam Shah Gate**

This double-storied gateway served as entrance to the step-well in the back. It is supposed to be built by Islam Shah during the regime of his father Sher Shah Suri (1540-45 CE). A marble slab fixed over the entrance gate is engraved with an inscription in *Nastaliq* characters.

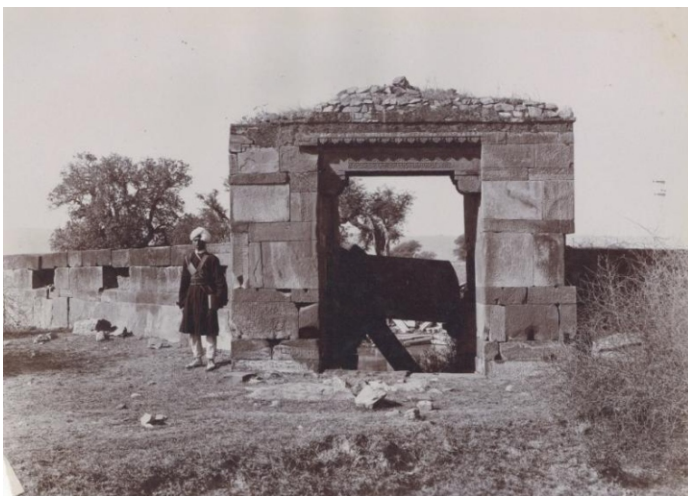
**An archival photo of Jhalar Baoli Northeastern  
Doorway**

The Jhalar Baoli is a large reservoir located outside the town. According to an inscription dated to 1318–1319 CE found at the baoli, it is the earliest dated reservoir in the Bayana region and also one of the earliest Muslim-period reservoirs in the area. The structure is monumental in scale and features shaded porticoes, which were plausibly designed for the convenience and leisure of large groups of people, indicating that it functioned as a public utility. The inscription also mentions the name of the reigning Sultan along with its patron, Kafur Sultani.
